Manhole Inspection Summary

Manhole # S35Q__002MH

Location Address: **patapsco st**

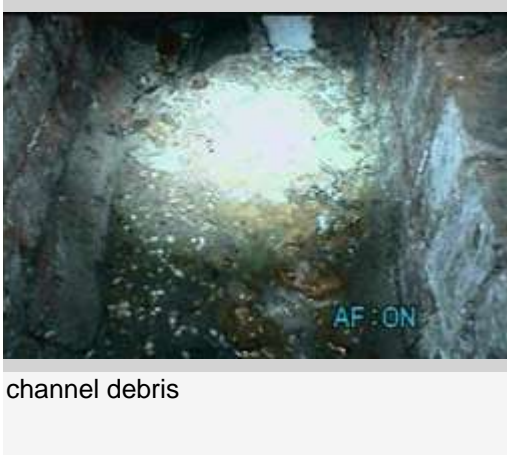
Defect 3

Condition: ☐ Sound ☐ Cracked ☐ Root Intrusion ☐ Deteriorated ☐ Leaks ☒ **Debris**

channel debris

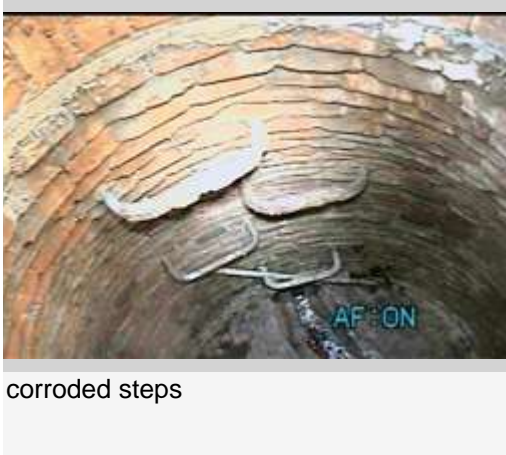
Defect 2

Count: **4** Missing: **0** ☒ **Corroded**

corroded steps

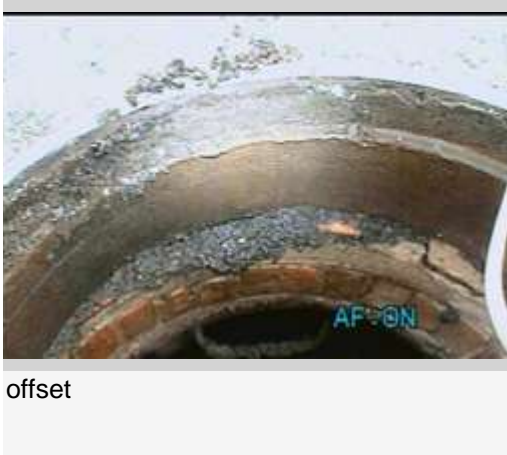
Defect 1

Offset: **1** (in.)

offset

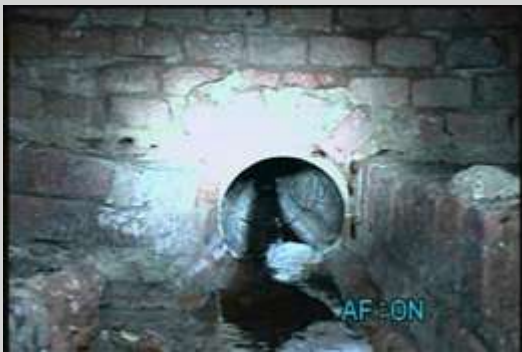
12 O'Clock Outflow

8 in. Circular Gravity Sewer
Pipe Out @ 12 O'Clock

Invert Depth: **9.90** (ft.) Flow Characteristics: **Slow**

Deposits: ☒ None ☐ Mud ☐ Sludge ☐ Debris ☐ Grease

Infiltration: **None** Pipe Seal Cond: **Unknown**

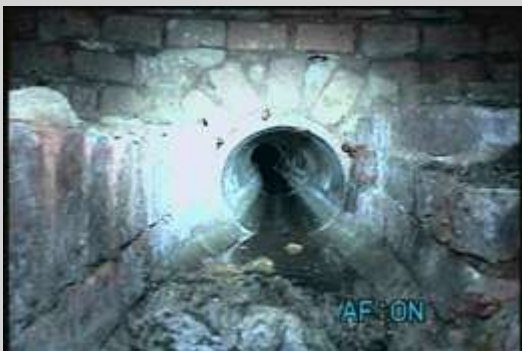
6 O'Clock Inflow

8 in. Circular Gravity Sewer
Pipe In @ 6 O'Clock

Invert Depth: **9.80** (ft.) Flow Characteristics: **Slow**

Deposits: ☒ None ☐ Mud ☐ Sludge ☐ Debris ☐ Grease

Infiltration: **None** Pipe Seal Cond: **Unknown**

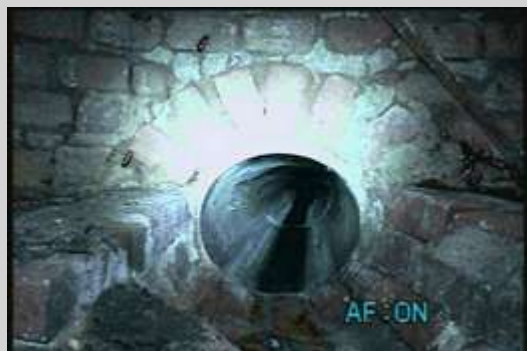
9 O'Clock Inflow

Pipe In @ 9 O'Clock

Invert Depth: **8.70** (ft.) Flow Characteristics: **Slow**

Deposits: ☒ None ☐ Mud ☐ Sludge ☐ Debris ☐ Grease

Infiltration: **None** Pipe Seal Cond: **Unknown**
